Defects identification of the main gas pipelines**Yu.V. Banakhevych^{1*}, R.Yu. Banakhevych²**¹*Ivano-Frankivsk National Technical University of Oil and Gas;
15, Karpatska Str., Ivano-Frankivsk, 76019, Ukraine*²*MPD «Lvivtransgaz»;
3, I. Rubchaka Str., Lviv, 79000, Ukraine*

This paper describes a typical case of diagnosing and determining the causes of the forming of longitudinal cracks on the outer surface of the pipe, analyzes the current state of diagnosis of main gas pipelines. There is shown the importance of timely and correct response to diagnostic results. There is considered the experience in carrying out measures to optimize the repair processes of main gas pipelines by clearly establishing the timing of both evaluating the results of internal pipe diagnostics and the forming of repair plans, substantiating the criteria for choosing defects for repair and establishing a unified approach to the process, including technical documentation.

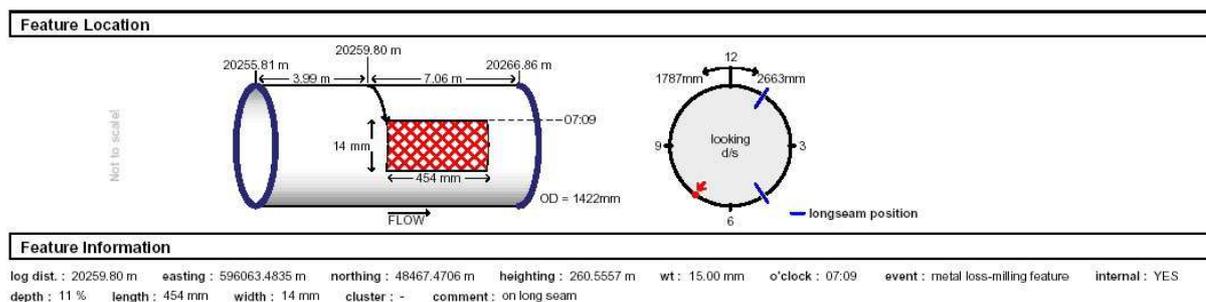
An interesting and, by its nature, a unique case occurred in 2008 on the Urengoy–Pomary–Uzhgorod Du 1400 Ru gas pipeline of 7.400 MPa. According to the results of a piston pass in August 2007 to identify longitudinal defects in the section of the Ilintsi – Bar compressor station at 3871.81 km of the Urengoy – Pomary – Uzhgorod (UPU) gas pipeline (20,259.8 m from the launch chamber, according to ROSEN), there was detected a defect identified as metal loss – factory anomaly on a longitudinal weld with a depth of 11 % of the pipe wall thickness, 454 mm long, 14 mm wide. Figure 1 shows a fragment of the defect passport according to the technical report of the Rosen company [8], which performed an in-pipe inspection of the gas pipelines of PJSC "Ukrtransgaz" in 2007.

Figure 1 – The fragment of the defect passport according to the technical report provided by ROSEN

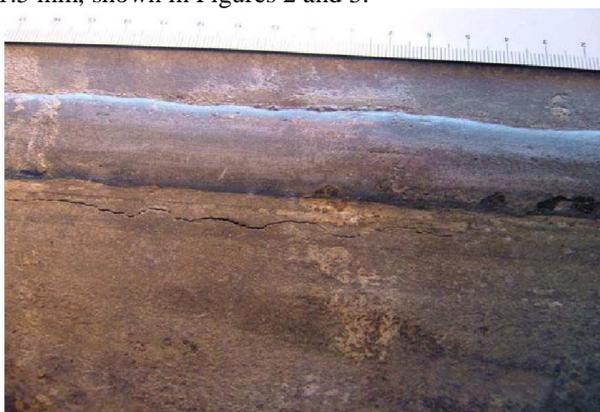
detector, there was found cracking of the main metal of the pipe body with a length of 3000 mm and a depth of 1.5 mm, shown in Figures 2 and 3.

Figure 2 – Longitudinal crack (frontally)

a crack with a total length of up to 3000 mm (in the area of stepped surface layering), which is located along the welded joint and has an intermittent nature and the seepage on the pipe metal;

White corrosion (carbon film) on the surface of the gas pipeline metal under the insulation layer indicates the presence of a carbonate medium in the vicinity of the gas pipeline, which is formed as a result of the long-term effect of concrete weights on the soil environment. This is evidenced by the results of electrometric measurements and determination of the pH areas around the pipe soil medium.

The carbon film has protective properties against soil corrosion on the metal, as evidenced by the non-corroded metal surface. But during operation, the metal of the gas pipeline is subject to cyclic loads, which contributes to the cracking of the carbonate film in the longitudinal direction and the emergence of crack-like local anode zones, which in their turn are the center of corrosion cracking.

The potentially hazardous section of the UPU gas pipeline, which is located at 3871.81 km, was repaired by replacing the defective section with another one using materials that meet the requirements [10].

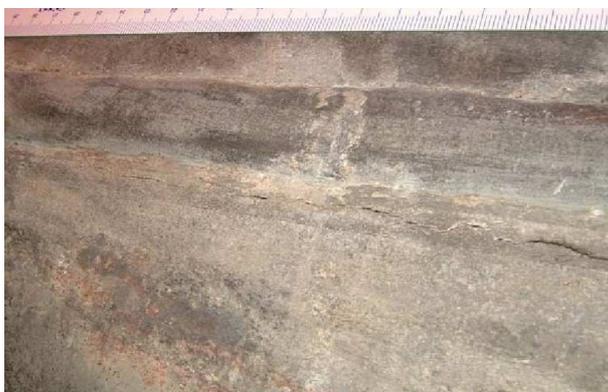
Figure 3 – Other cracks in the vicinity of the pipe seam

The occurrence of a stepwise layering of the pipe metal surface and longitudinal lines in the vicinity of the seam zone of the longitudinal weld is due to the improper location of the pipe billet in the mandrel stand during the expansion at the manufacturer. During the operation of the gas pipeline, the local stepwise layering of the pipe surface is the center of the increased mechanical stresses of the metal at the annular intersection of the gas pipeline, the designations of which can go beyond the elastic zone of the metal, which is confirmed by stress state studies. The factors identified determine the possible causes of cracking on the outer surface of the pipeline.

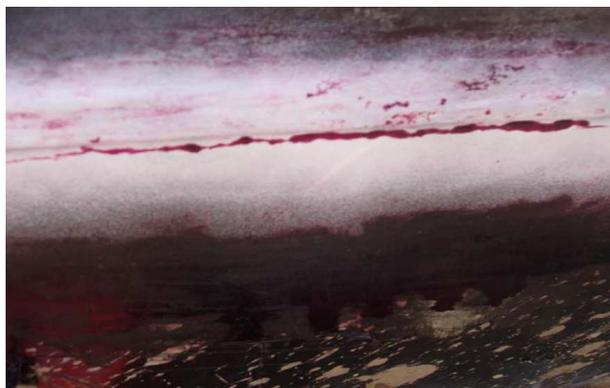
When conducting capillary inspection of a section in the vicinity of the seam zone of a longitudinal welded joint of a DN 1400 pipe (Fig. 4), it was found that a number of surface cracks with branched ends with a total length of up to 3000 mm are located on the surface of the gas pipeline metal at a distance of 7–15 mm from the longitudinal weld which tend to unite among themselves in the direction along the generatrix of the gas pipeline.

Figure 4 – General view of the surface after diagnosis by capillary control

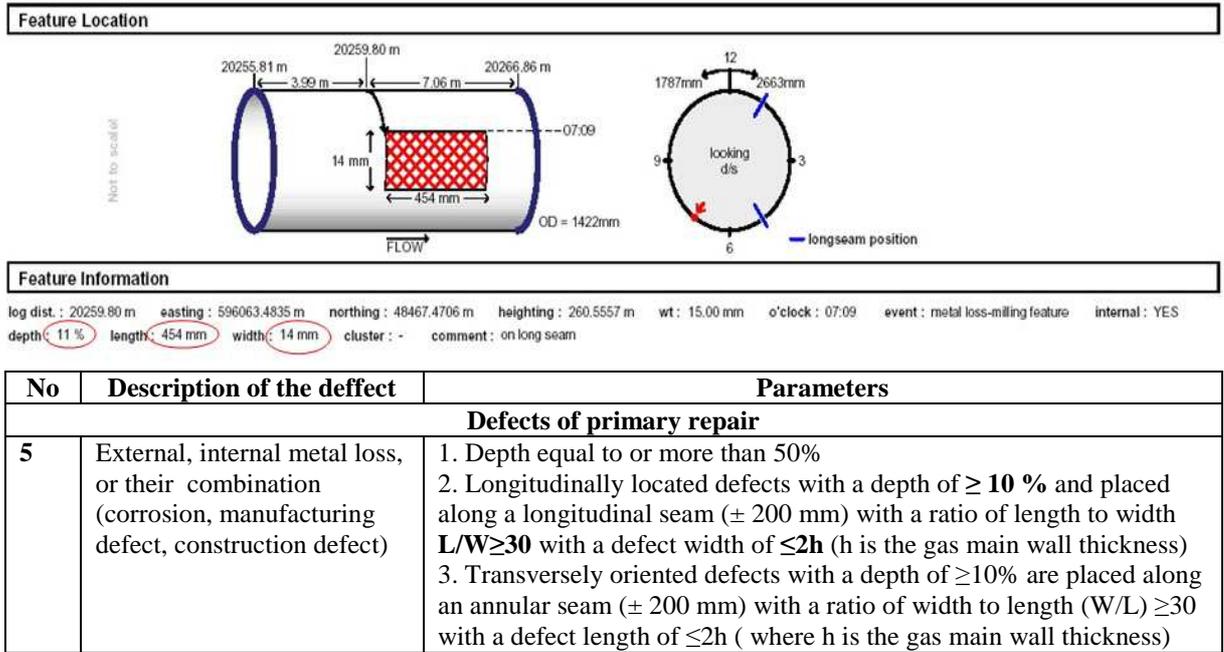
Figure 6 – Criteria for assessing defects typed as metal loss

A number of defect selection parameters for inspection/repair are determined on the basis of existing operating experience and are sometimes quite conservative, but in the face of too high a price error, in particular at export gas pipelines of Ukraine, is a justifiable measure. Everyone knows the problems of the limited capabilities of in-pipe inspection tools regarding the detection of stress-corrosion cracking. There is a sad experience of accidents, additional flaw detection control, where defects discovered in fact differed from the characteristics indicated in the in-pipe inspection report. As an example, we recall, again, a defect in the Urengoy–Pomary–Uzhgorod gas trunkline 3871.81 km (see Fig. 2, 3) when, contrary to the information of the IPI report, stress-corrosion cracking was actually revealed. In order to prevent the possible ignoring of such defects, we introduced such a criterion as: "external metal losses are longitudinally oriented with a depth of $\geq 10\%$ and are placed along a longitudinal weld (± 200 mm) with a length to width ratio of ≥ 30 with a defect width of $\leq 2h$ (h – pipeline wall thickness)." Figure 6 shows the establishing such a criterion for assessing defects on DN1400 pipes.
